Dover Stormwater Asset Management Plan

Town of Dover MA

October 2025

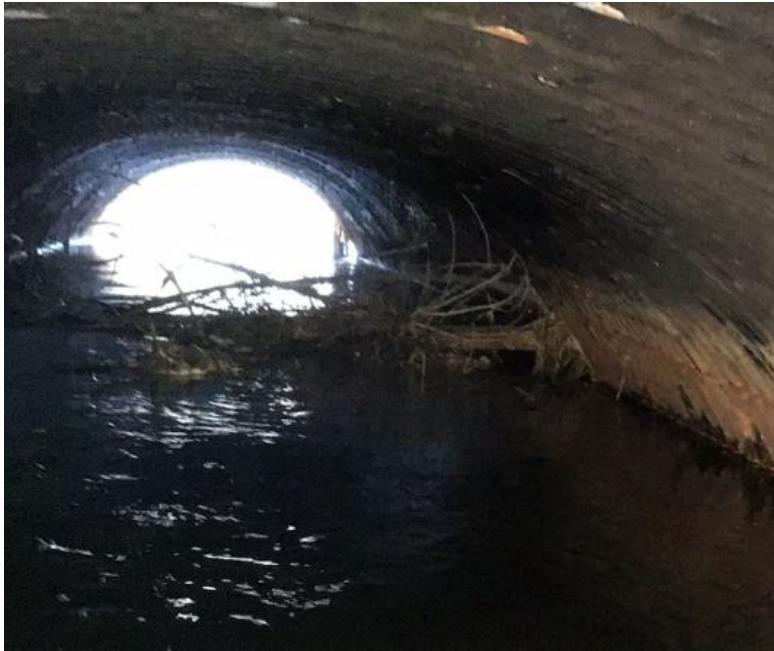
PRIORITY CULVERT: 11, HAVEN ST

- Change in culvert materials
- Poor structural integrity
- Poor blockage/ root intrusion
- Fallen headwall stones

Recommendation:
Replacement

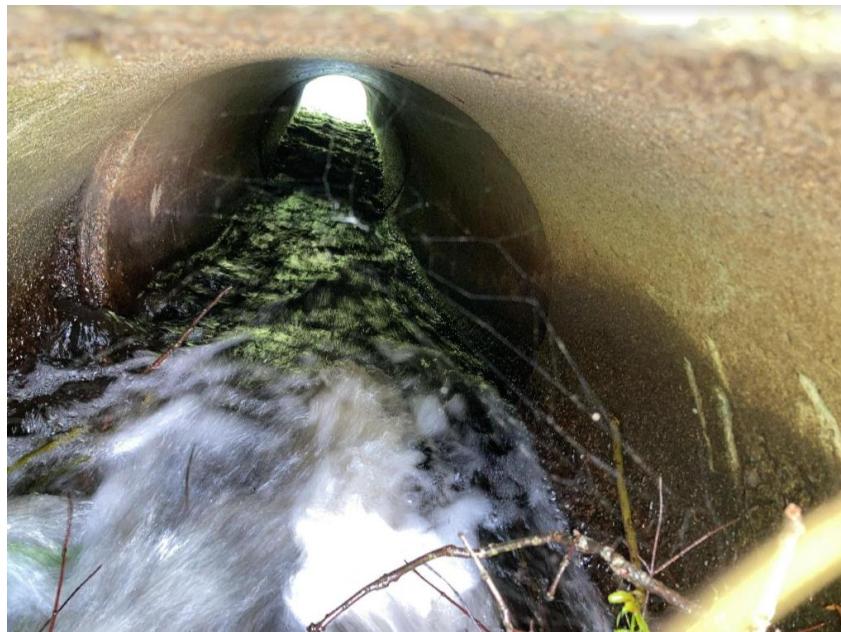
PRIORITY CULVERT: 10, CLAYBROOK ROAD

- Poor blockage
- Critical headwall/wingwalls
- Poor embankment
- Appears undersized

Recommendation:
Replacement

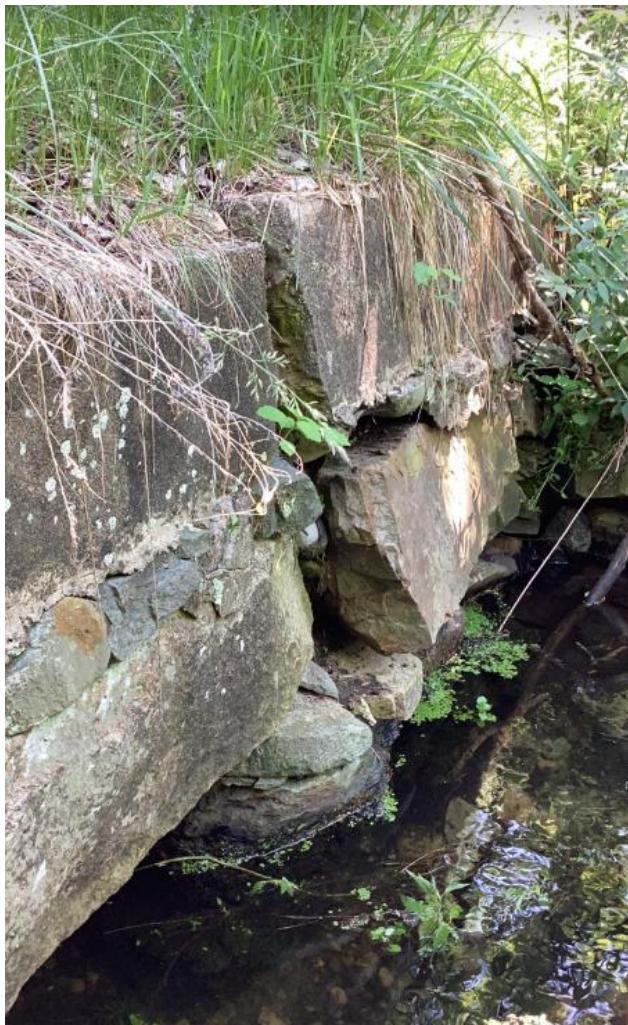
PRIORITY CULVERT: 60, SPRINGDALE AVE

- Poor blockage
- Poor headwall/wingwalls
- Poor joints and seams

Recommendation:
Rehab until replacement

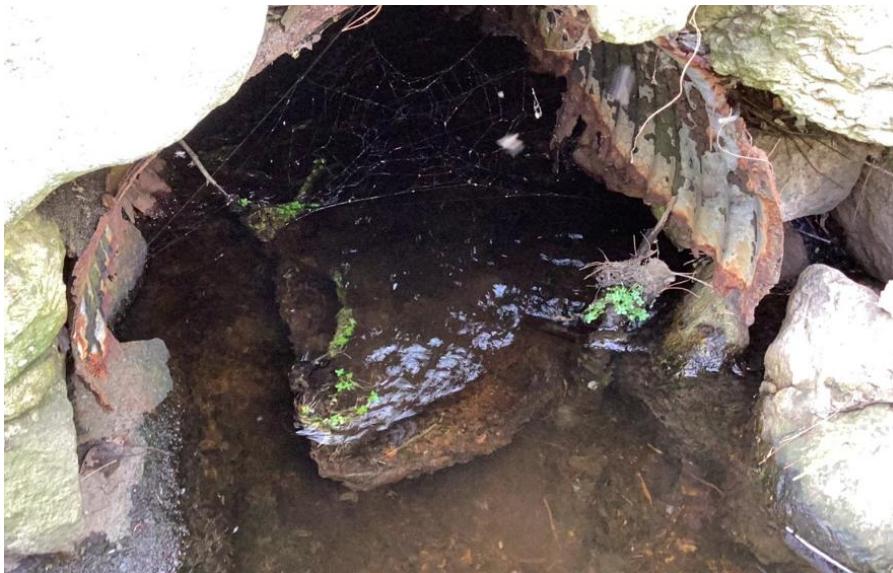
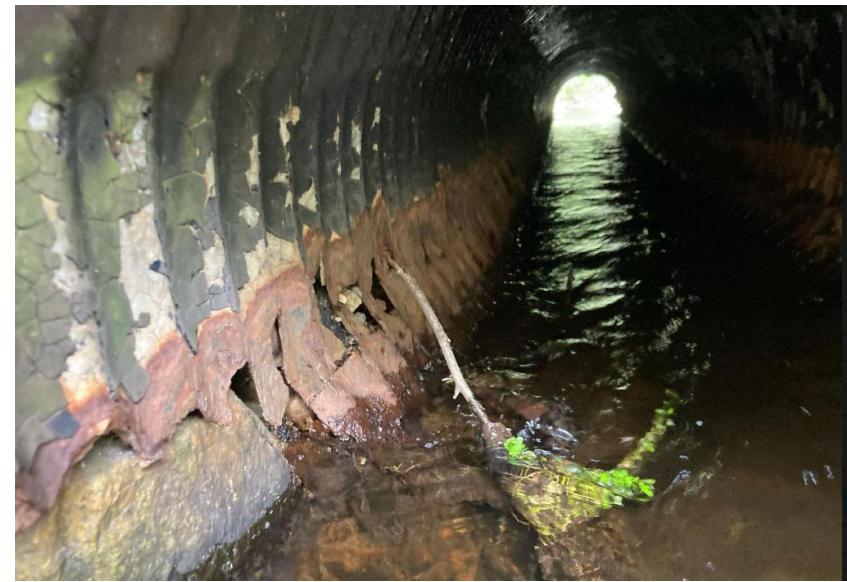
PRIORITY CULVERT: 66, HARTFORD ST

- Poor structural integrity
- Critical invert deterioration
- Poor headwall/wingwalls

Recommendation:
Replacement

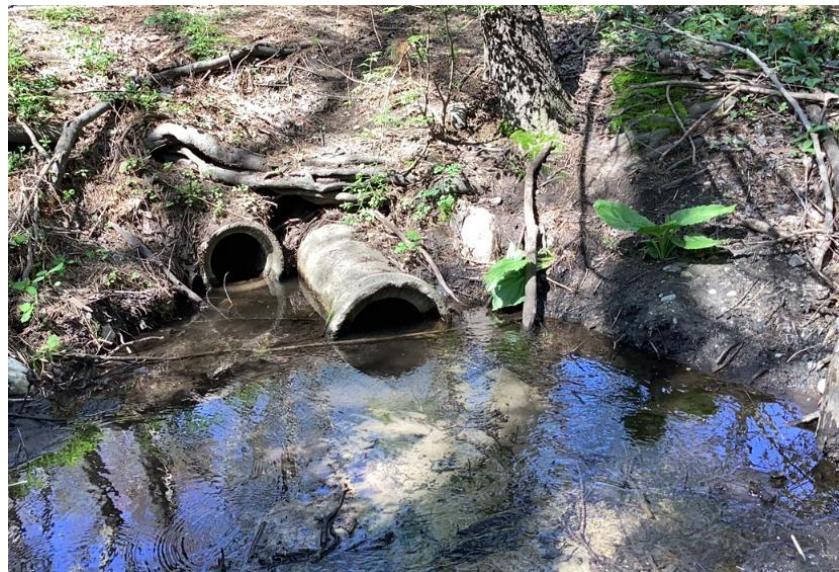
PRIORITY CULVERT: 86, OLD FARM RD

- Poor joints and seams
- Poor longitudinal alignment
- Poor blockage

Recommendation:
Replacement
