Dover Stormwater Asset Management Plan

Town of Dover MA

October 2025

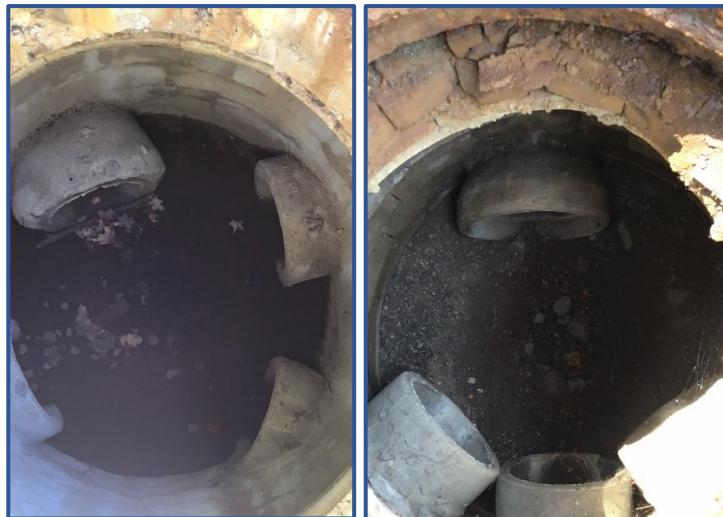
Figure 2-3 Example Manhole Condition

Figure 2-3 includes an example of a drain structure that is in sound condition (the block drain manhole on the left) and an example of a drain structure that had defects observed (the block manhole on the right). The structure on the right was found to have missing/displaced blocks in the chimney. Structures with observed defects should be repaired or monitored, especially as it relates to undermining the roadway.

Left Image is of drainage manhole in sound condition (DMH-7). Right image is of drainage manhole with defective conditions (DMH-103)

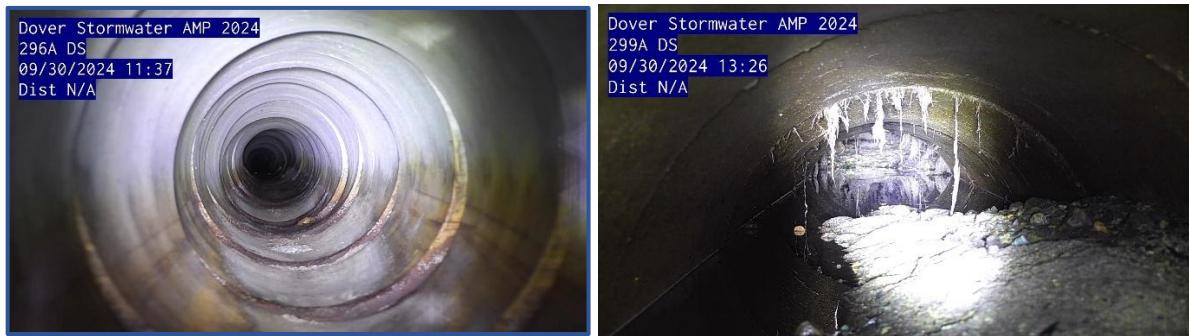
Figure 2-4 Example of Sedimentation in Pipes

Most of the pipes inspected had very little sediment, but about 9% of the pipes inspected were more than 40% full. This is demonstrated in **Figure 2-4**.

Left Image is of a drainage pipe less than 40% full of sediment (Pipe-296A). Right image is of a drainage pipe more than 40% full of sediment (Pipe 299A)

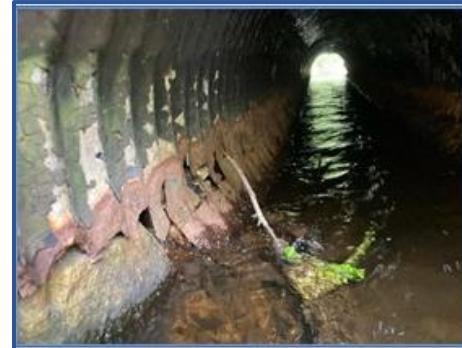
Of the 13 CMP culverts assessed, eight (8) were small diameter (up to 2 feet) and five (5) were larger diameter (greater than 2 feet). 54% of the assessed CMP culverts had some level of invert deterioration (see an example shown in **Figure 3-1**), which will require more aggressive monitoring of the culvert condition in terms of deterioration and blockages.

Figure 3-1 Example of invert deterioration in a CMP culvert (Culvert 66)

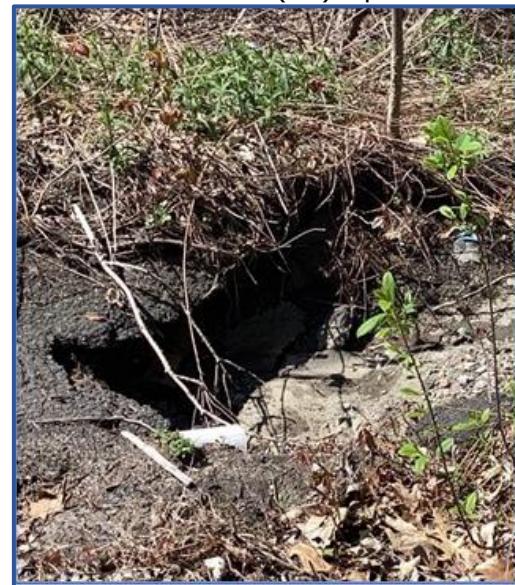
Poor or critical roadway embankment conditions were noted at sixteen (16) upstream locations and fourteen (14) downstream locations. Poor roadway embankment conditions show severely undermined embankment protection (significant erosion of the embankment) and should be repaired as soon as possible. Critical roadway embankments noted have severe scour of the embankment and threaten the stability of the roadway, as shown in **Figure 3-2**. These should be addressed immediately. Of the 16 upstream locations, one (1) is noted as critical. Of the 14 downstream locations, three (3) are critical. The culverts identified as having critical embankment(s) are included in **Table 3-7**. **Appendix H** includes a summary of roadway embankment concerns.

Figure 3-2 Example of a culvert with a tree at the headwall and critical roadway embankment (Culvert 4)

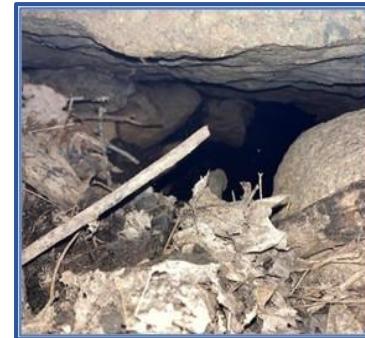
Figure 3-3 Example of Critical Obstruction at Culvert Inlet

Obstructions were observed at the culverts, including items such as screens or grates, wood, sediment, trash, piled vegetation or rocks, and debris. Some of the culverts had severe obstructions that limited the assessment of the barrels condition. **Figure 3-3** demonstrates the critical obstruction of TPC-29 because sediment and debris was built up, blocking the entire culvert inlet. The obstructions identified in the field are summarized in **Table 3-10**. These culverts should be further investigated and/or addressed as needed, and the condition of the culvert reevaluated once addressed.

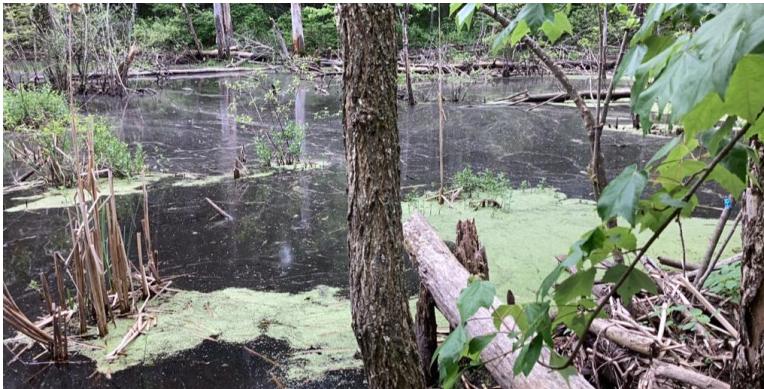
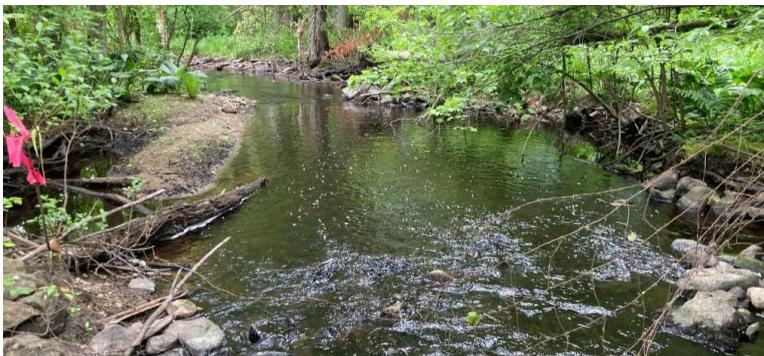
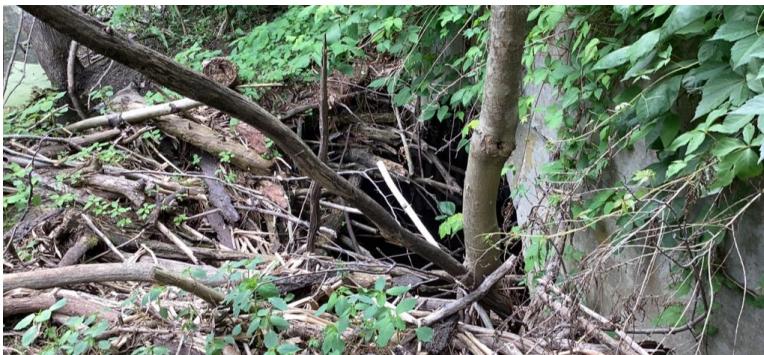
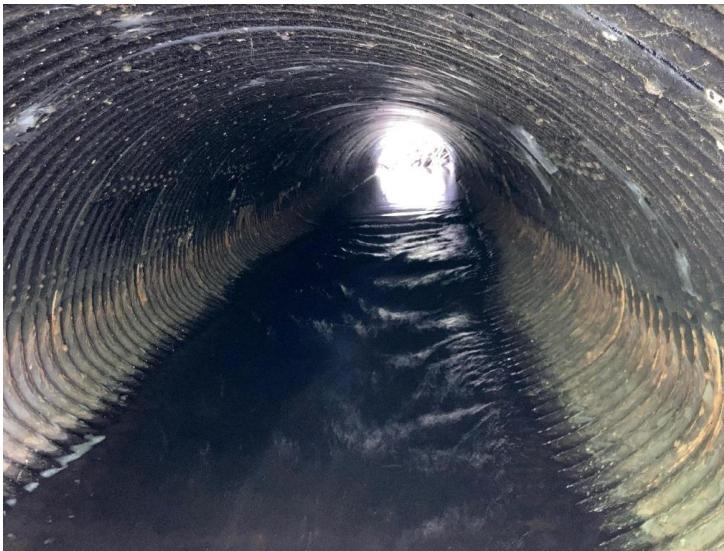
PRIORITY CULVERT: 51, DEDHAM ST

- Corrugated metal
- Poor structural integrity
- Undersized leading to blockages
- Located in cold water fishery
- Located in FEMA flood zone

Recommendation:
Replacement

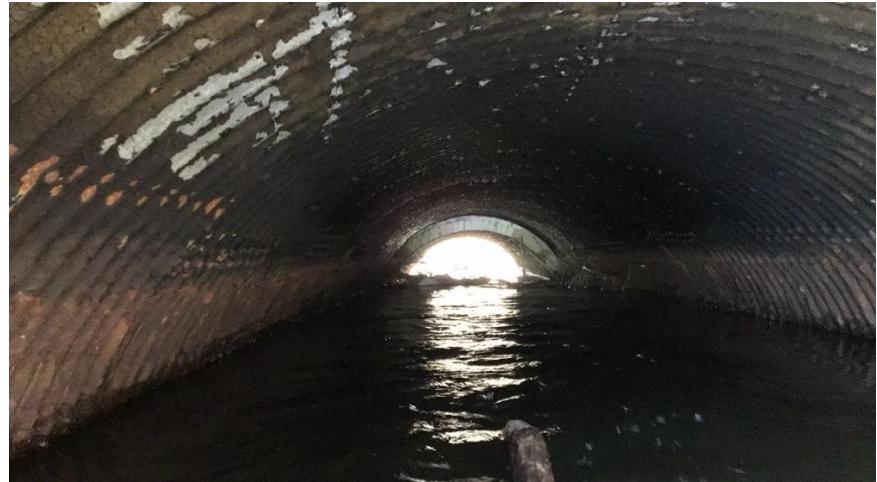
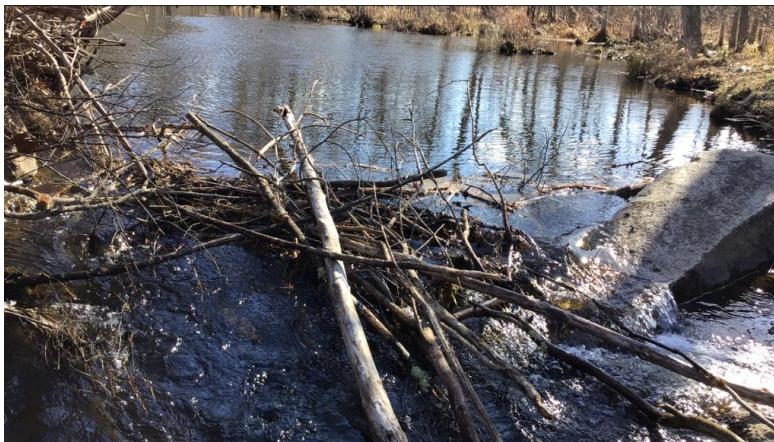
PRIORITY CULVERT: 11, HAVEN ST

- Change in culvert materials
- Poor structural integrity
- Poor blockage/ root intrusion
- Fallen headwall stones

| Culvert ID | Road Name | Criticality Score | Recommendation | Notes | Opinion of Probable Cost | | | | |
|--|---|---|---|--|--|---|---|---|---|
| 11* | Haven Street | High | Replace - DER grant | CHP; deteriorating metal; heavy blockage | \$ 100,000.00 | \$ 500,000.00 | | | |

Recommendation:
Replacement

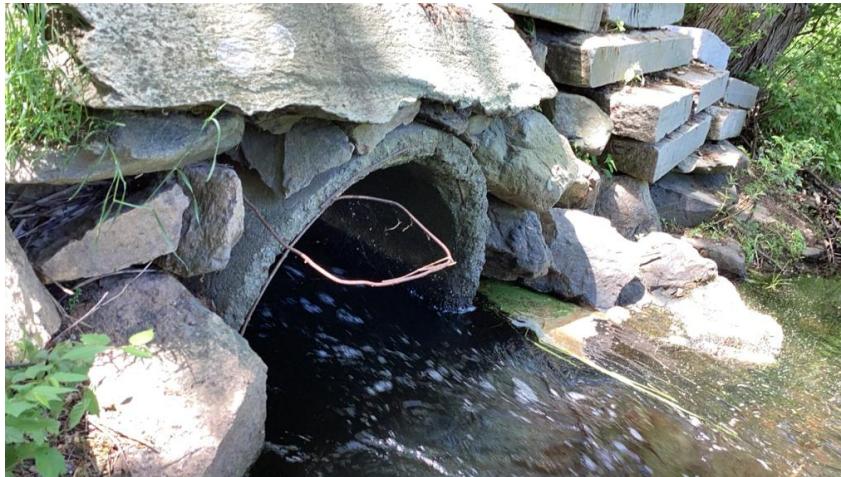
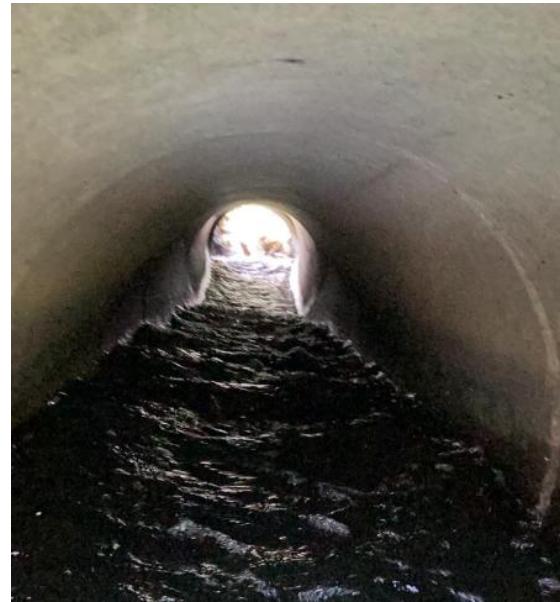
PRIORITY CULVERT: 10, CLAYBROOK ROAD

- Poor blockage
- Critical headwall/wingwalls
- Poor embankment
- Appears undersized

| Culvert ID | Road Name | Criticality Score | Recommendation | Notes | Opinion of Probable Cost | | | | |
|--|---|---|---|--|--|---|---|---|---|
| 10* | Claybrook Road | Medium-High PoF | Replace - DER grant | RCP; failing headwall; undersized, often blocked by beavers | \$ 100,000.00 | \$ 500,000.00 | | | |

Recommendation:
Replacement

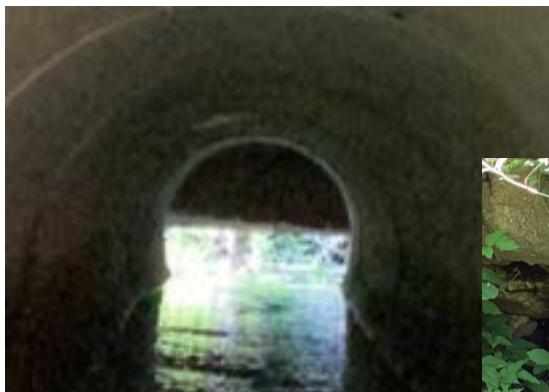
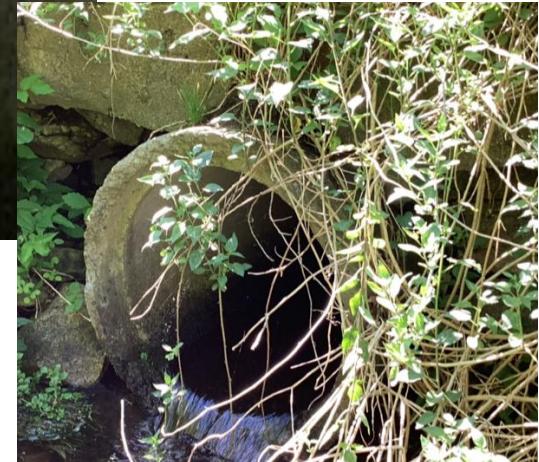
PRIORITY CULVERT: 60, SPRINGDALE AVE

- Poor blockage
- Poor headwall/wingwalls
- Poor joints and seams

| Culvert ID | Road Name | Criticality Score | Recommendation | Notes | Opinion of Probable Cost | | | | |
|--|---|---|---|--|--|---|---|---|---|
| 60* | Springdale Avenue | Medium-High PoF | Replace - DER study phase grant | RCP; undersized with invert deterioration, dammed | | \$ 100,000.00 | \$ 500,000.00 | | |

Recommendation:
Rehab until replacement

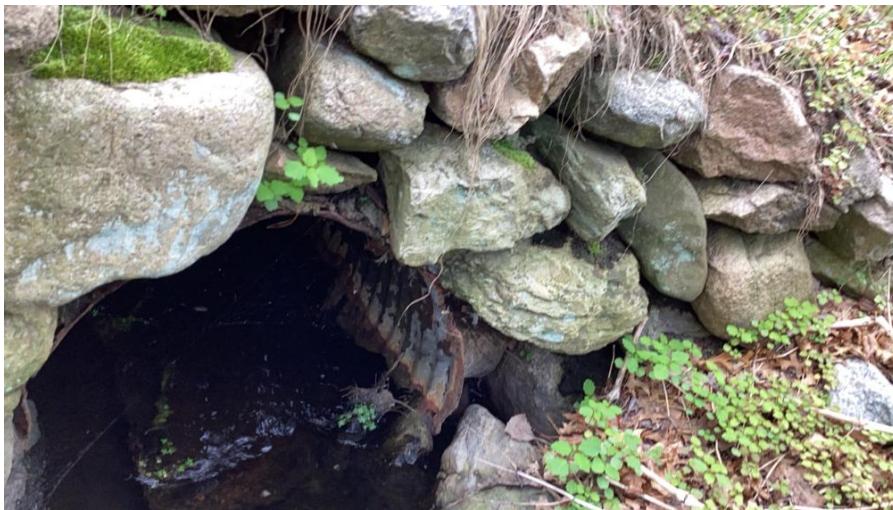
PRIORITY CULVERT: 66, HARTFORD ST

- Poor structural integrity
- Critical invert deterioration
- Poor headwall/wingwalls

Recommendation:
Replacement

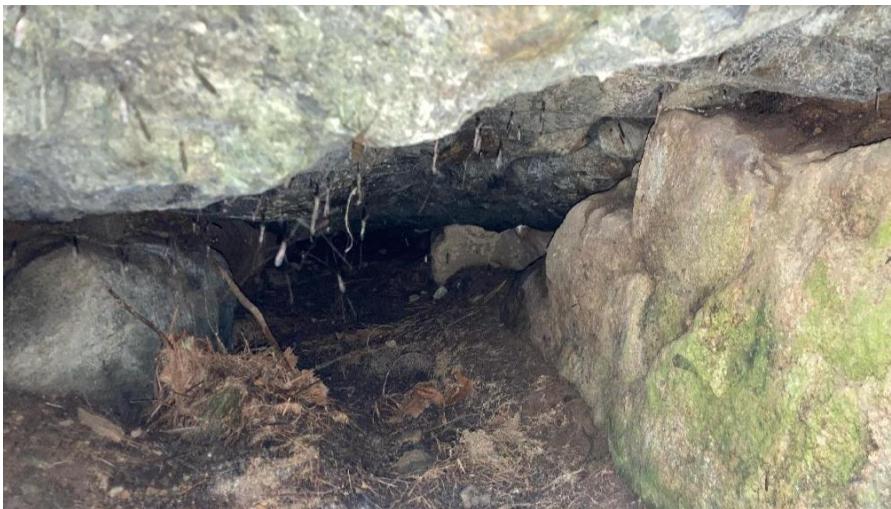
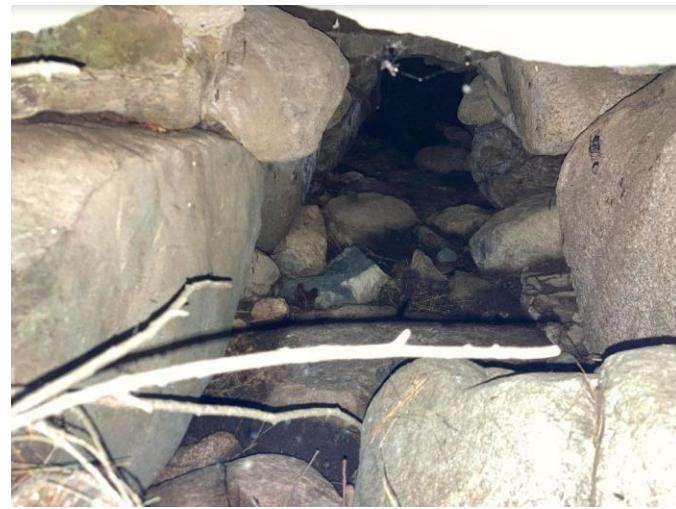
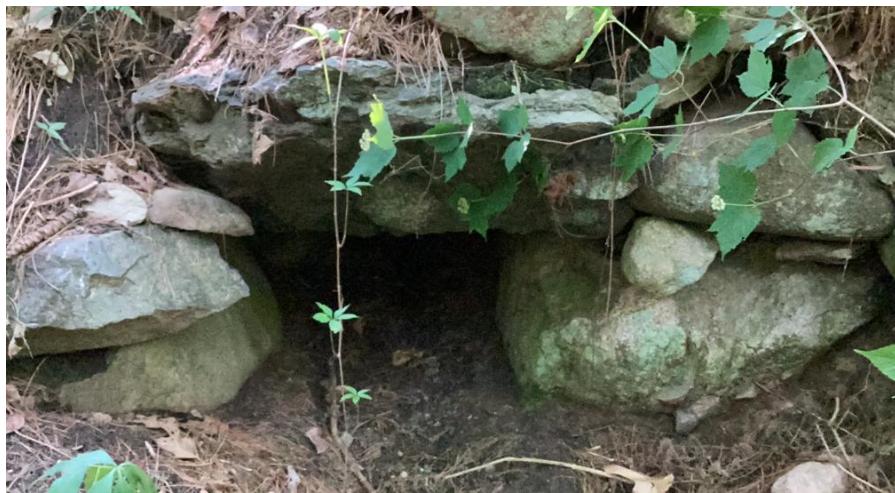
PRIORITY CULVERT: 82, SMITH ST

- Critical structural integrity
- Critical joints and seams
- Poor longitudinal alignment

| Culvert ID | Road Name | Criticality Score | Recommendation | Notes | Opinion of Probable Cost | | | | |
|--|---|---|---|--|--|---|---|---|---|
| 82* | Smith Street | Medium-High PoF | Replace - Put in catch basin and new pipe | Stone; critical structural integrity; Town would like to complete replacement in-house | \$ 100,000.00 | \$ 500,000.00 | | | |

Recommendation:
Replacement

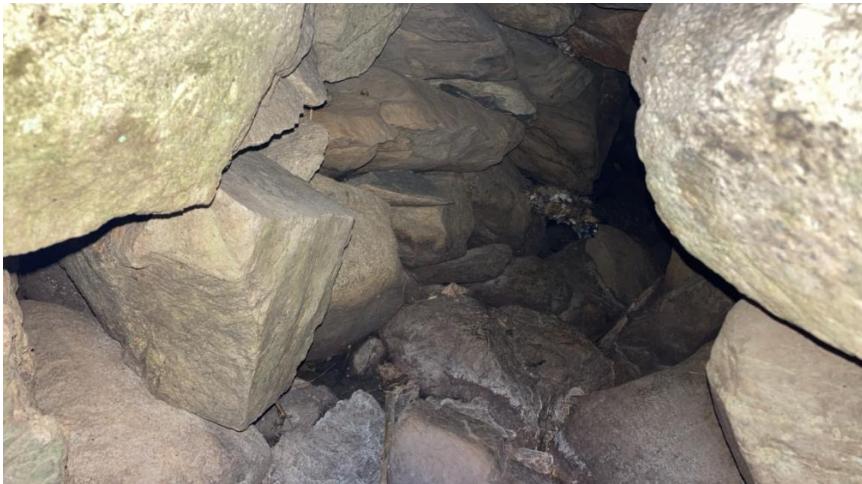
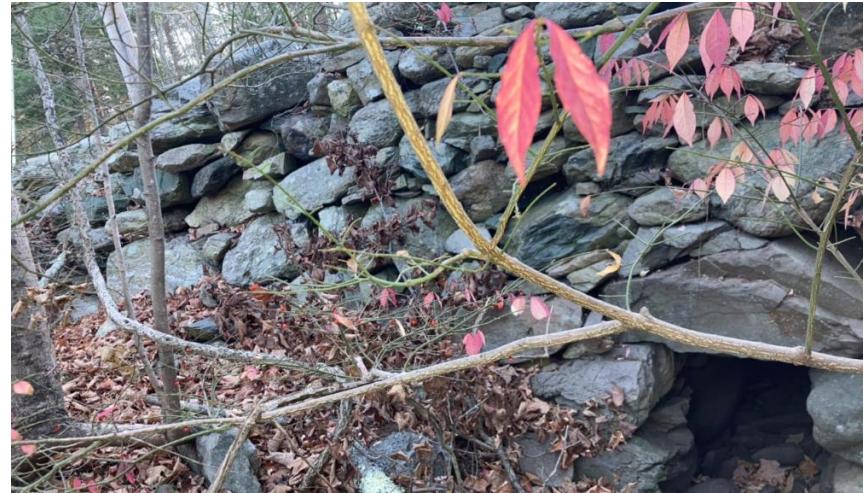
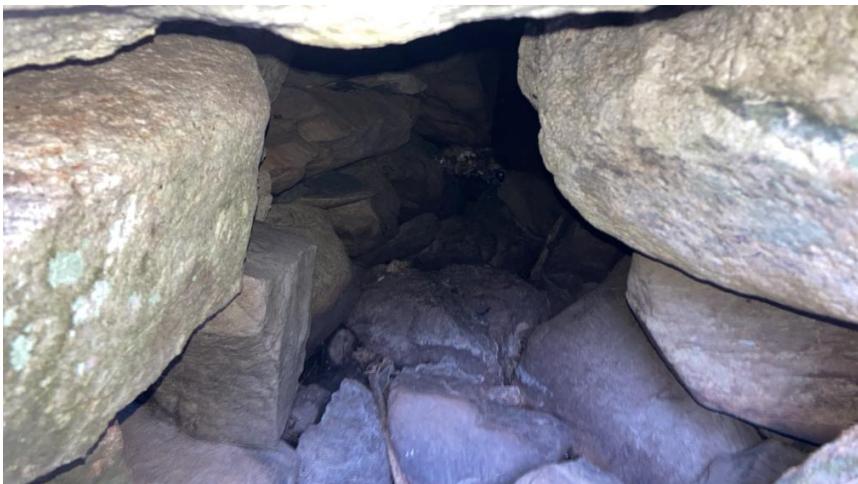
PRIORITY CULVERT: TPC-26, FARM ST

- Poor structural integrity
- Poor longitudinal alignment

| Culvert ID | Road Name | Criticality Score | Recommendation | Notes | Opinion of Probable Cost | | | | |
|--|---|---|---|--|--|---|---|---|---|
| TPC-26 | Farm Street | Medium-High PoF | Replace - 6' Box Culvert | Stone; failing stones; blockage and poor alignment | | \$ 283,000.00 | \$ 1,157,000.00 | | |

Recommendation:
Replacement

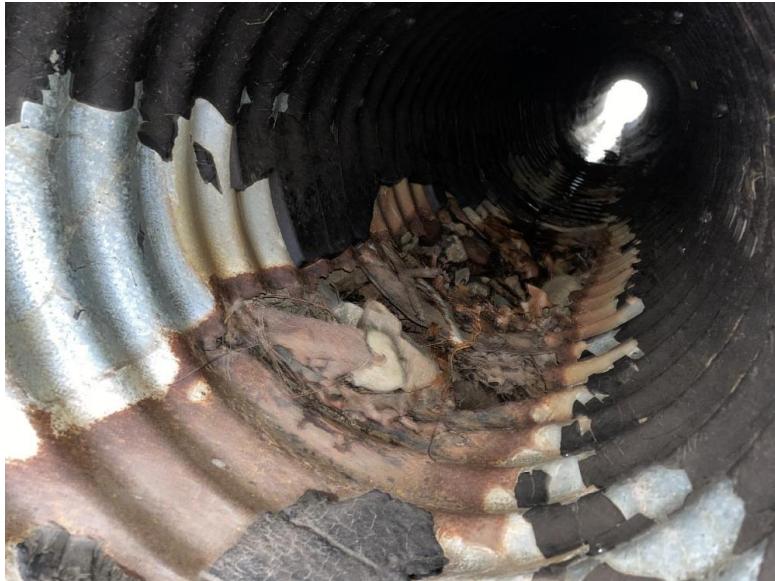
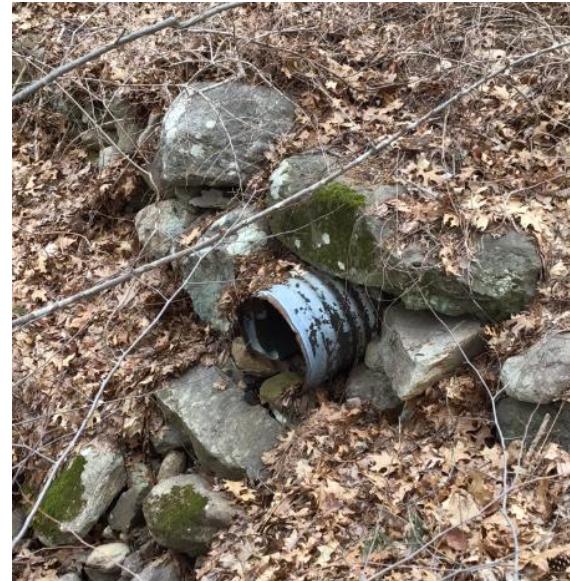
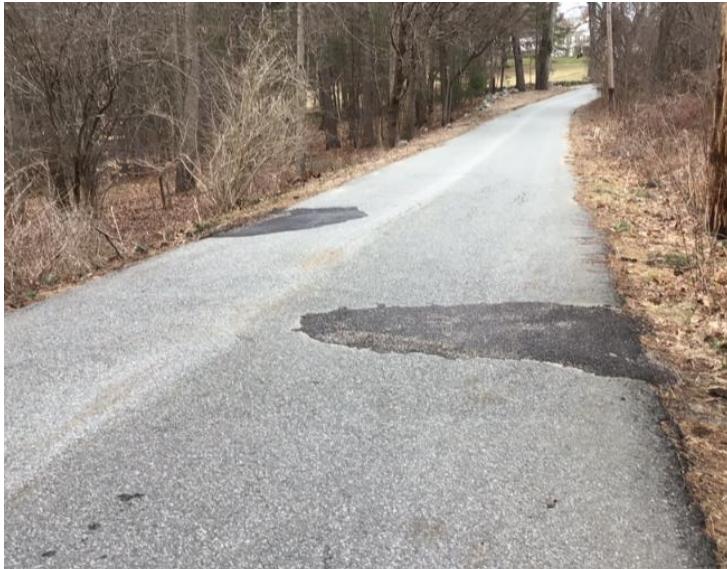
PRIORITY CULVERT: TPC-28, SMITH ST

- Critical invert deterioration
- Poor joints and seams
- Poor headwall/wingwalls

| Culvert ID | Road Name | Criticality Score | Recommendation | Notes | Opinion of Probable Cost | | | | |
|--|---|---|---|--|--|---|---|---|---|
| TPC-28* | Smith Street | Medium-High PoF | Replace | RCP; invert deterioration and failing headwall; Town would like to complete replacement in-house | | | \$ 100,000.00 | \$ 500,000.00 | |

Recommendation:
Replacement

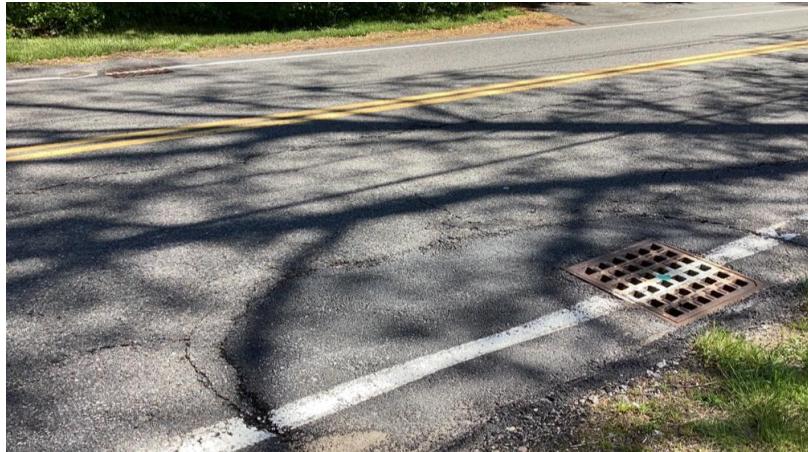
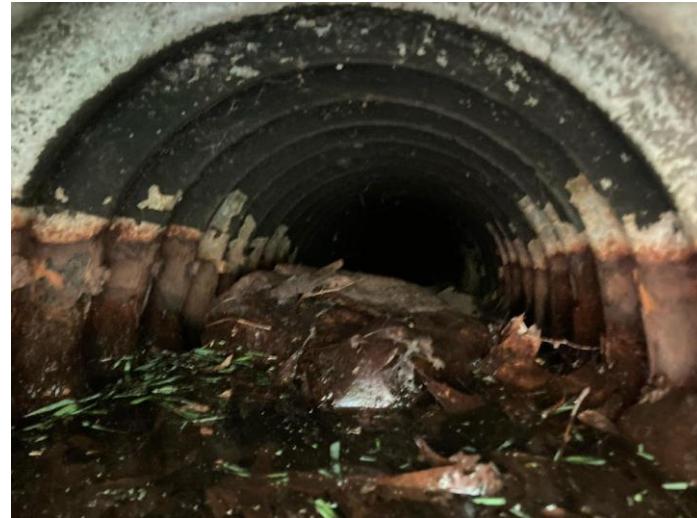
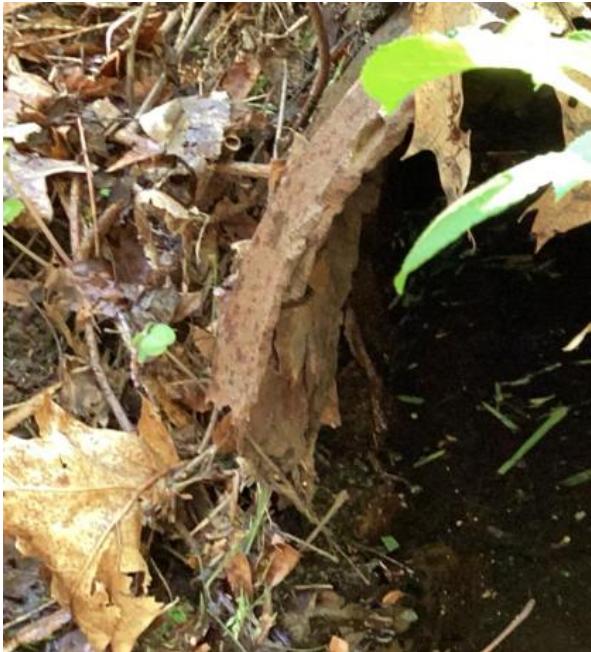
PRIORITY CULVERT: TPC-50, HARTFORD ST

- Critical invert deterioration
- Poor structural integrity

Recommendation:
Replacement

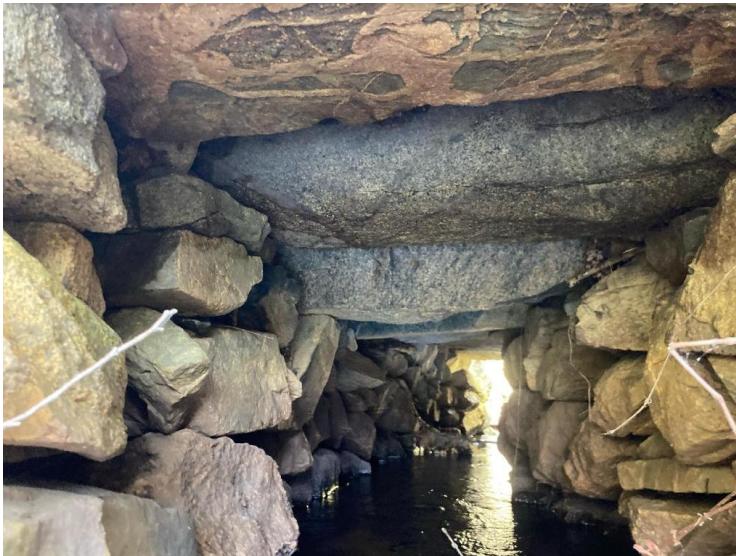
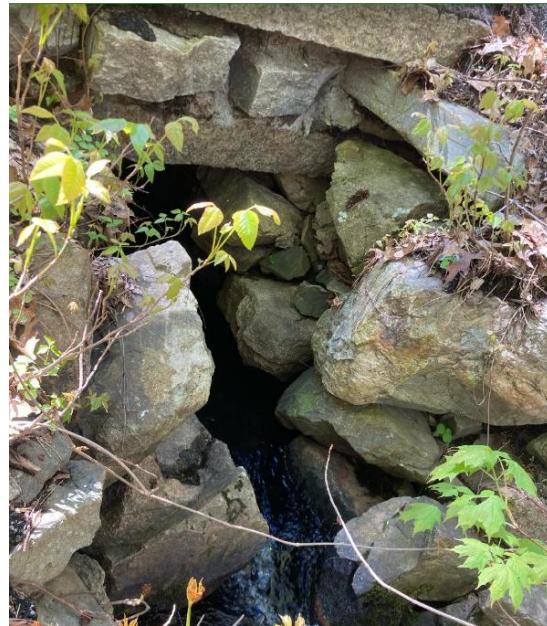
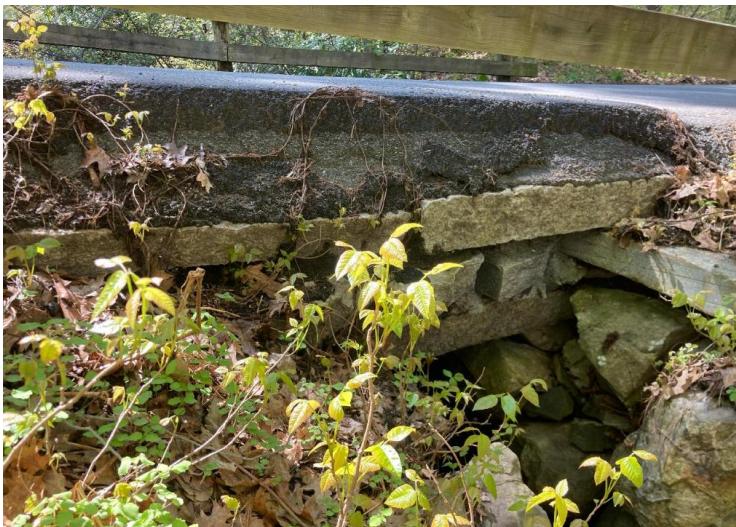
PRIORITY CULVERT: 62 WILSONDALE ST

- Poor headwall/wingwalls
- Poor structural integrity

| Culvert ID | Road Name | Criticality Score | Recommendation | Notes | Opinion of Probable Cost | | | | |
|--|---|---|---|--|--|---|---|---|---|
| 62* | Wilsondale Street | Medium-High PoF | Replace | Metal pipe; replace damaged pipe section, repair headwall | \$ 100,000.00 | \$ 500,000.00 | | | |

Recommendation:
Replacement

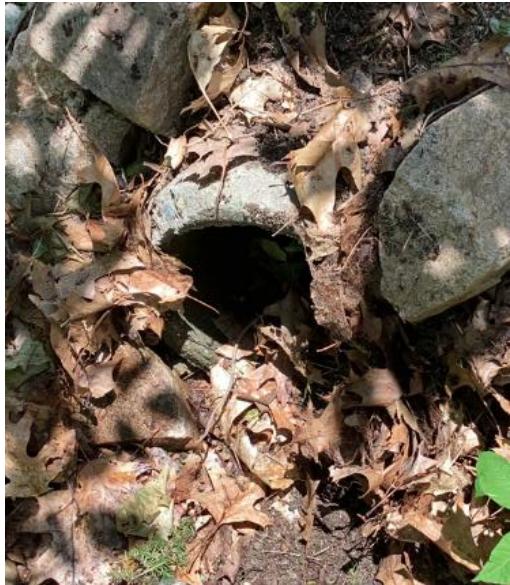
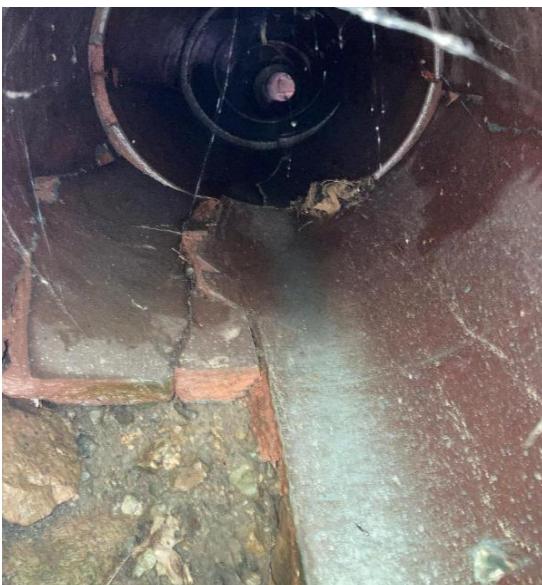
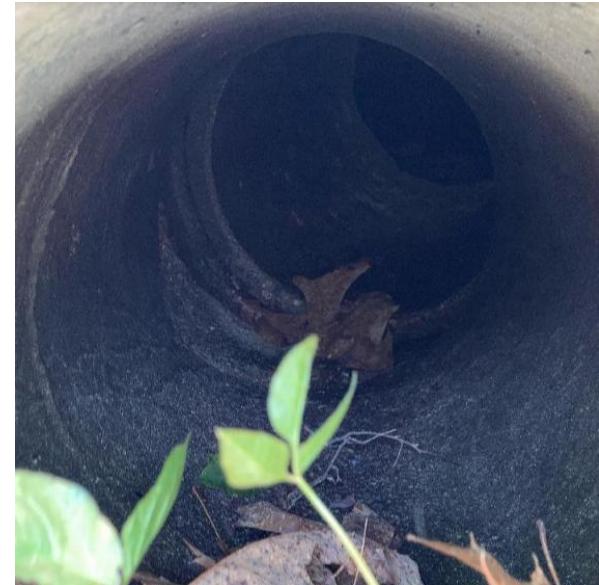
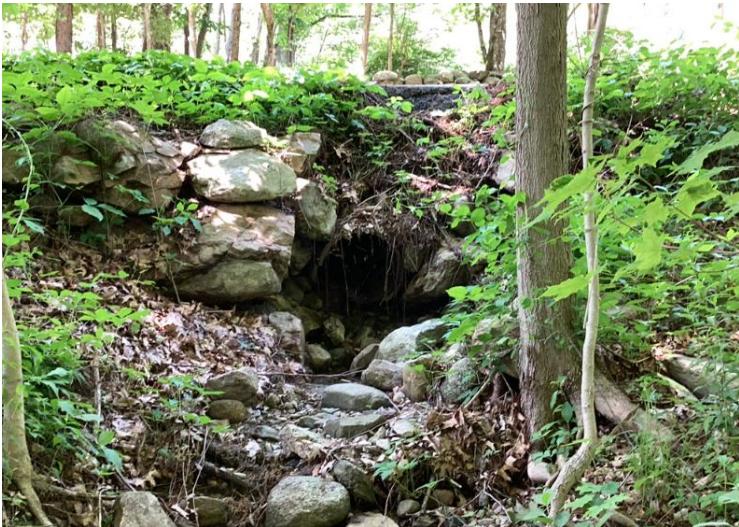
PRIORITY CULVERT: 78, FARM ST

- Critical invert deterioration
- Poor joints and seams
- Poor longitudinal alignment
- Poor headwall/wingwalls

| Culvert ID | Road Name | Criticality Score | Recommendation | Notes | Opinion of Probable Cost | | | | |
|--|---|---|---|--|--|---|---|---|---|
| 78 | Farm Street | Medium-High PoF | Partial demo and repair | RCP; undersized with blockage; floods upstream; Town would like to complete replacement in-house | | | \$ 140,000.00 | \$ 190,000.00 | |

Recommendation:
Partial demo & repair

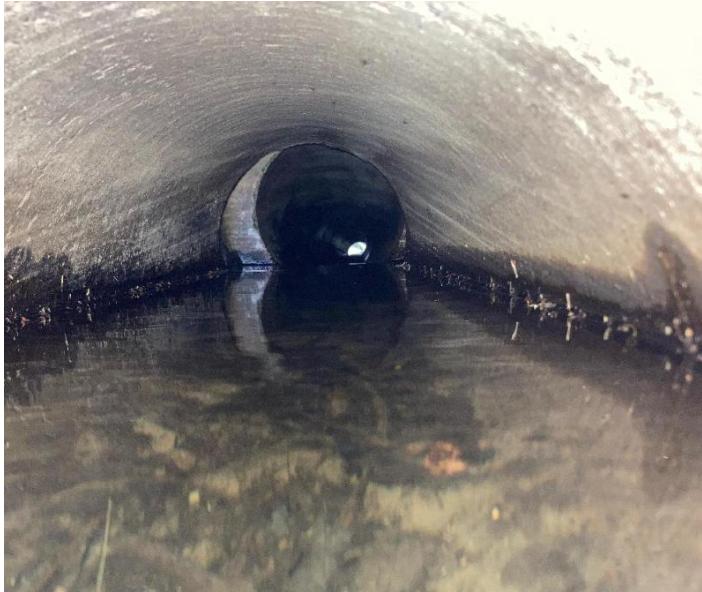
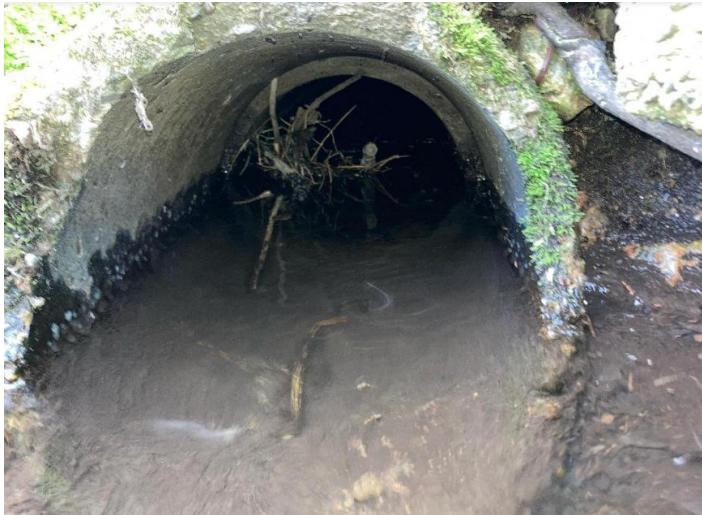
PRIORITY CULVERT: 86, OLD FARM RD

- Poor joints and seams
- Poor longitudinal alignment
- Poor blockage

Recommendation:
Replacement

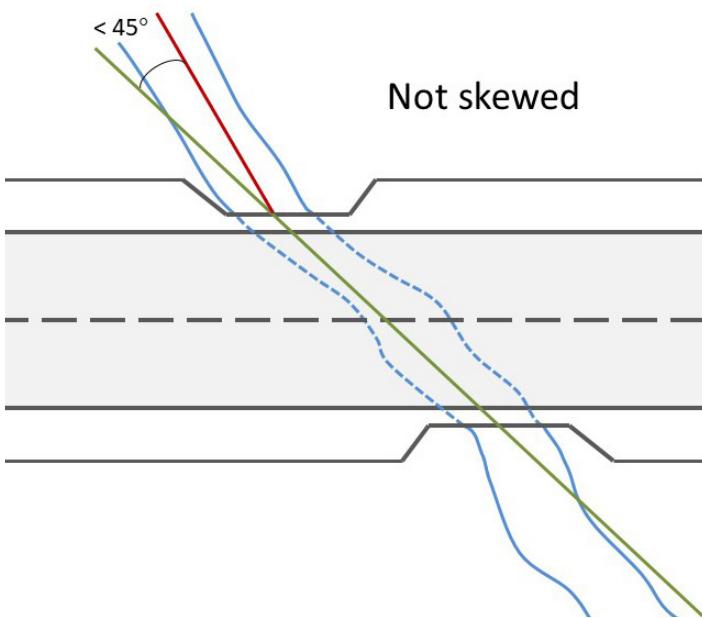
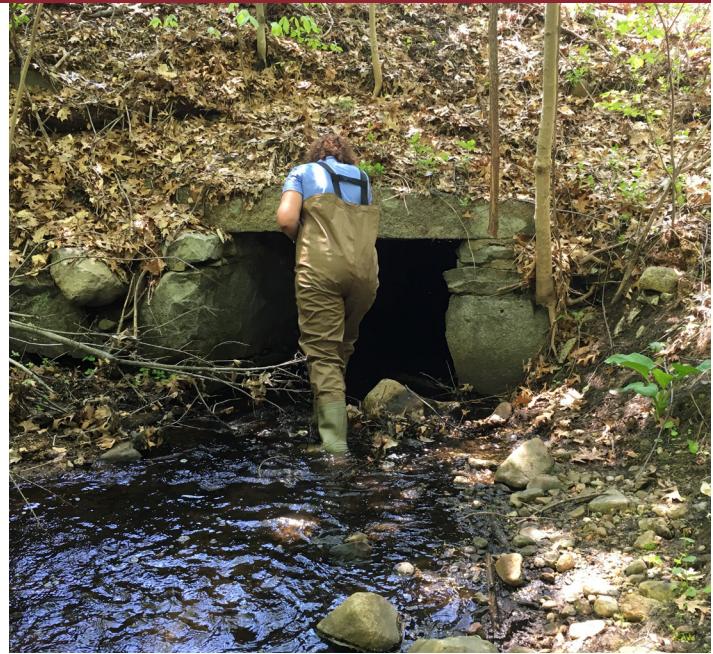
Adequate

Angle measured from upstream channel to centerline of culvert barrel is from 0-45 degrees.

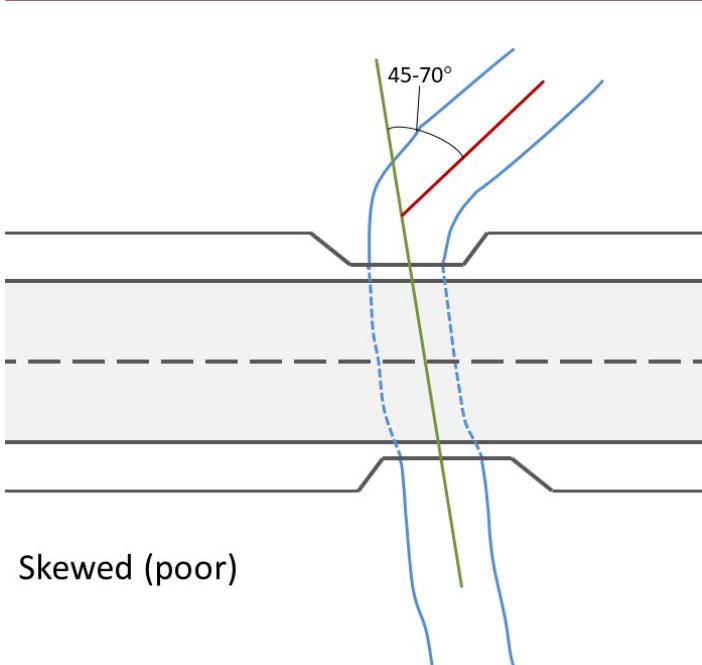
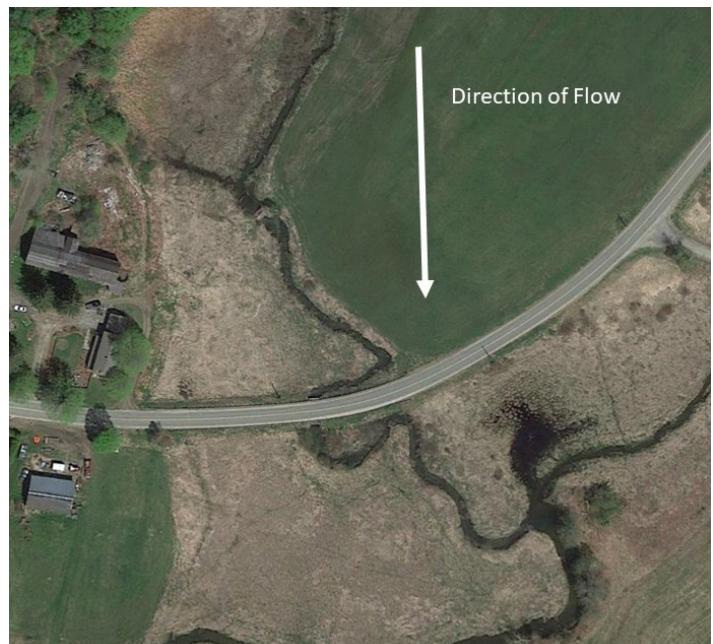
Poor

The stream channel approaches the crossing at an angle of 45-70 degrees from the centerline of the structure.

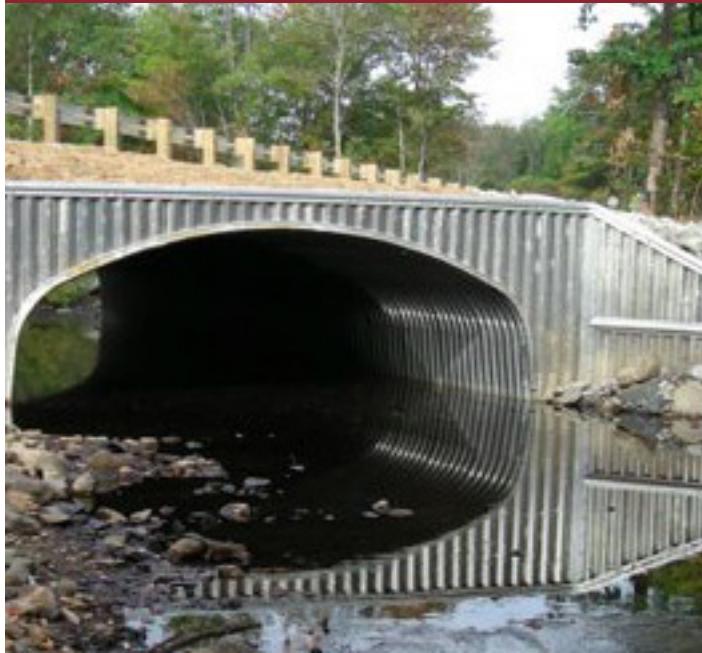
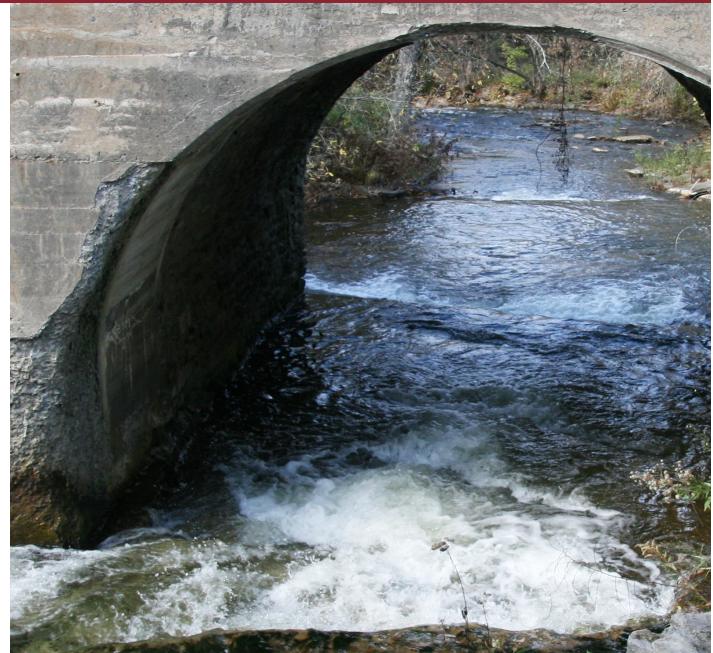
Adequate

Minor to moderate deterioration. Concrete - moderate cracking, scaling or leaching (minor delamination or spalling). Masonry - moderate weathering (minor joint deterioration). Slight settlement or undermining. Minor footing exposure.

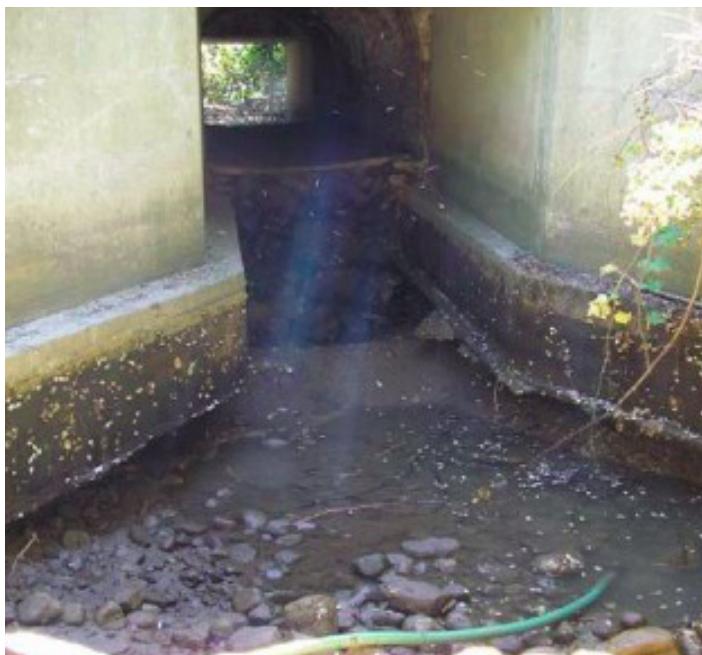
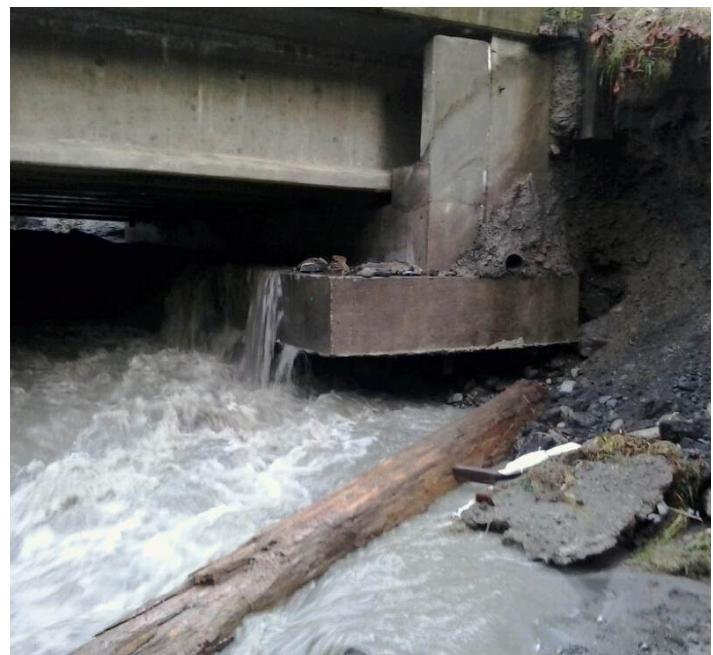
Poor

Extensive deterioration. Concrete - extensive cracking, scaling or leaching (delamination or spalling may be prevalent). Masonry - extensive weathering (significant joint deterioration). Significant settlement or undermining. Footing exposed and undermined.

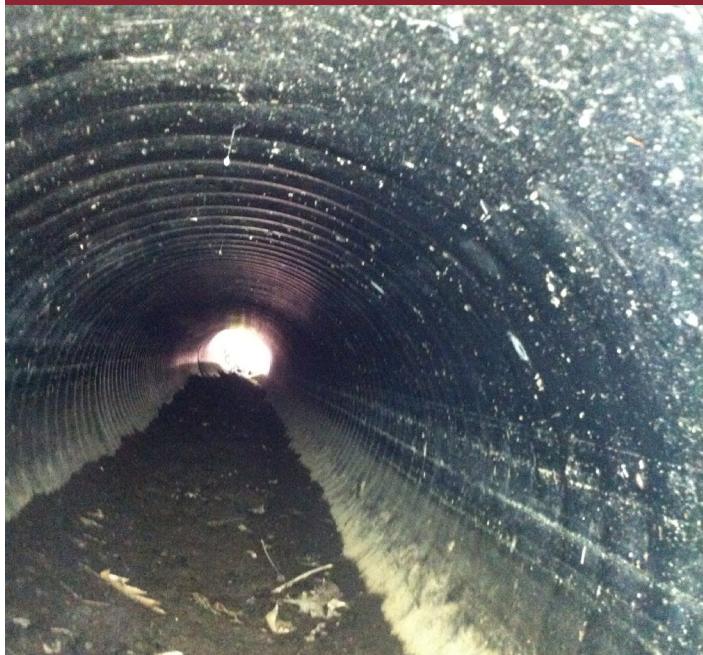
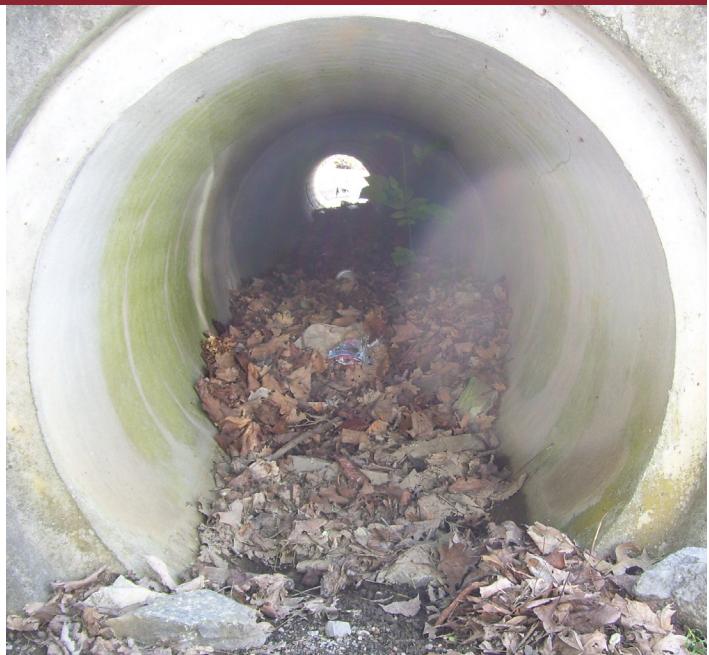
Adequate

Blockage is 10-30% of opening.

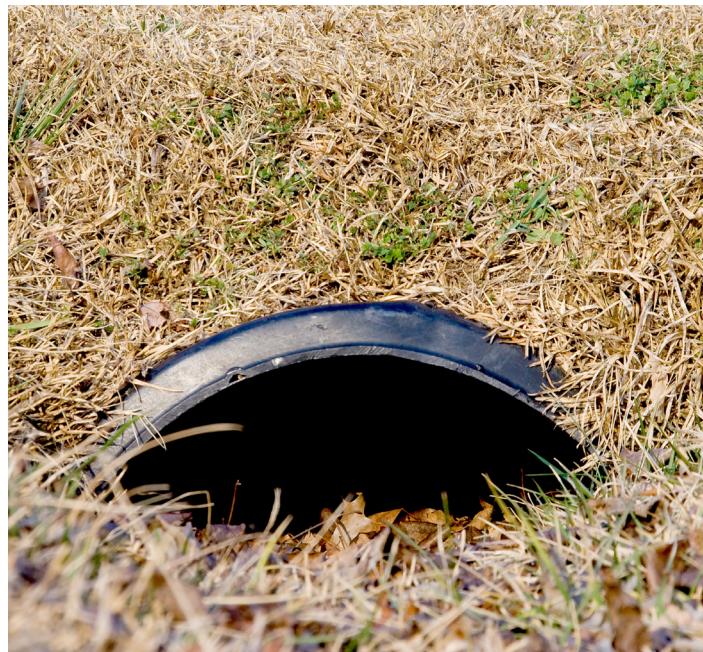
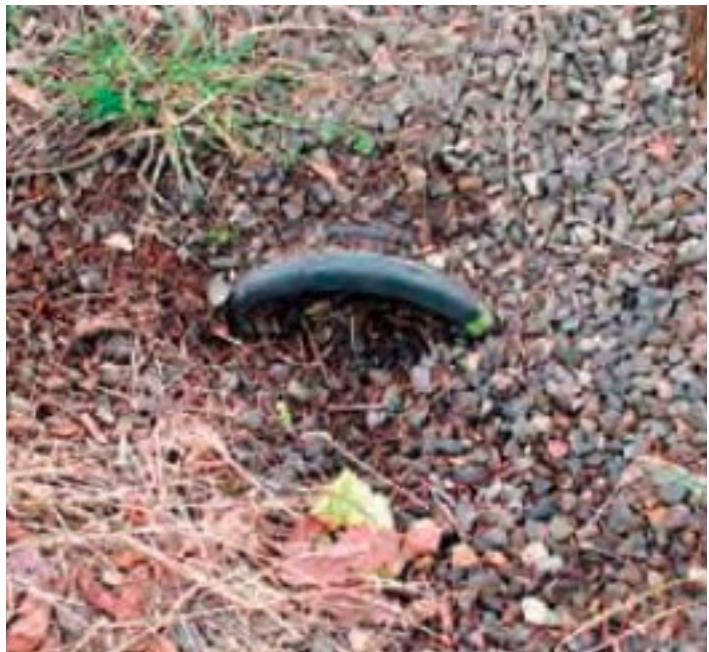
Poor

Blockage is 30-75% of opening.

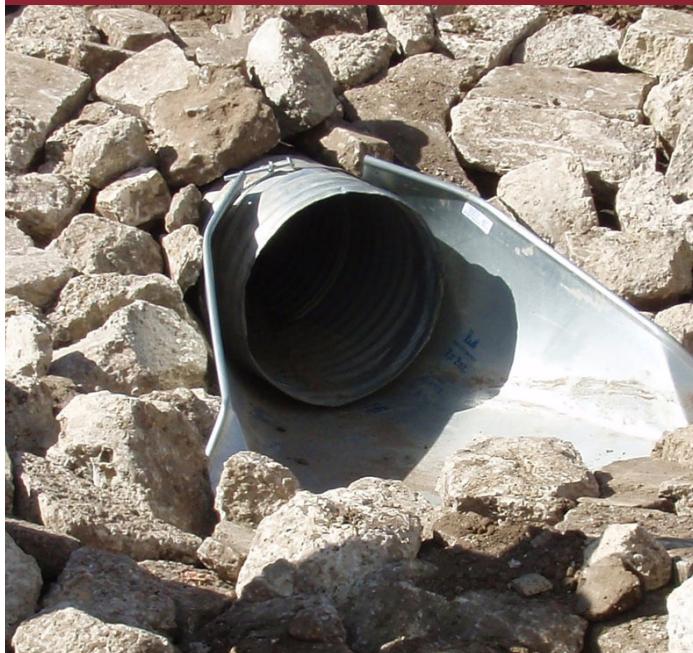
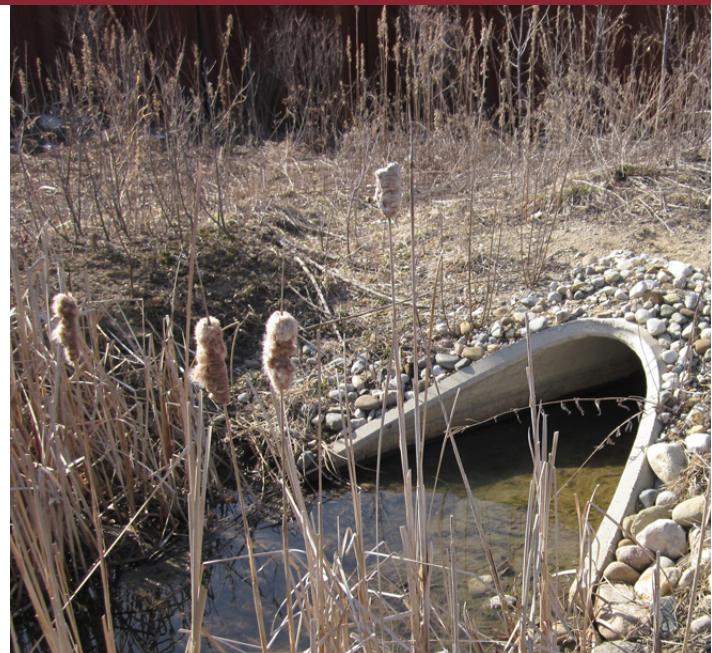
Adequate

Minor cracking, deterioration, or deformation. Minor undermining.

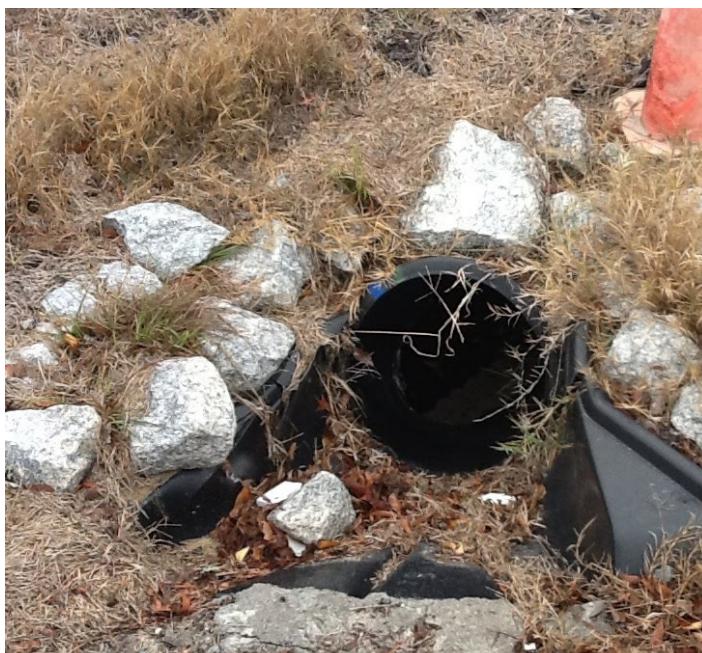
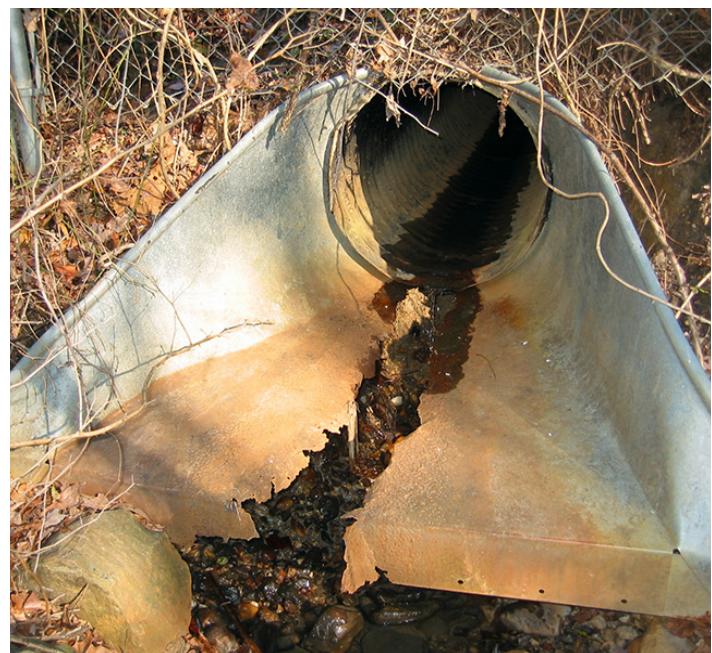
Poor

Significant cracks, piping or undermining affects >50% of appurtenance. End crushed or separated from barrel.
