Dover Stormwater Asset Management Plan

Town of Dover MA

October 2025

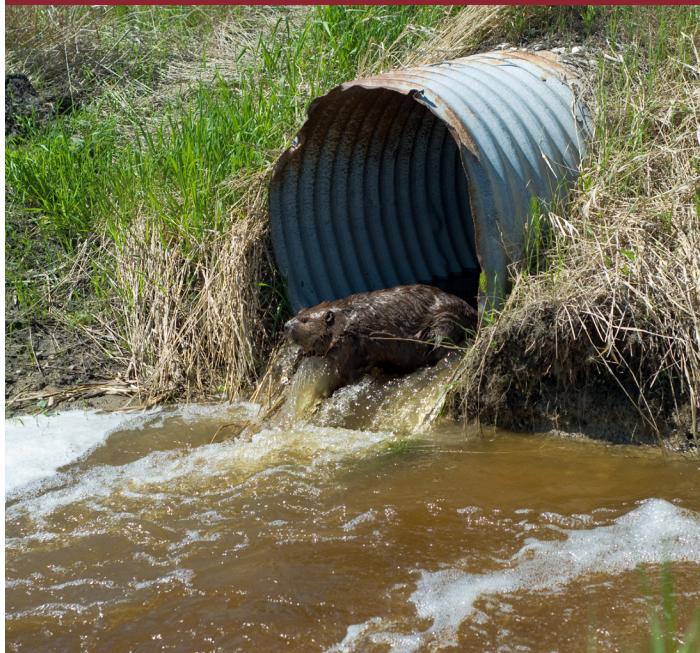
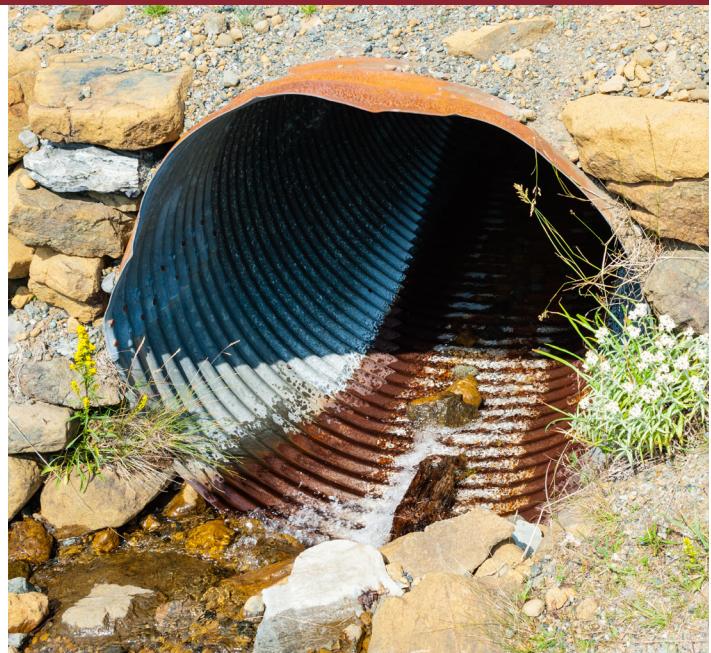
Adequate

Hydraulic uplift is overcome by a combination of the weight of the pipe, weight of the fill material over the pipe and weight of the water in the pipe.

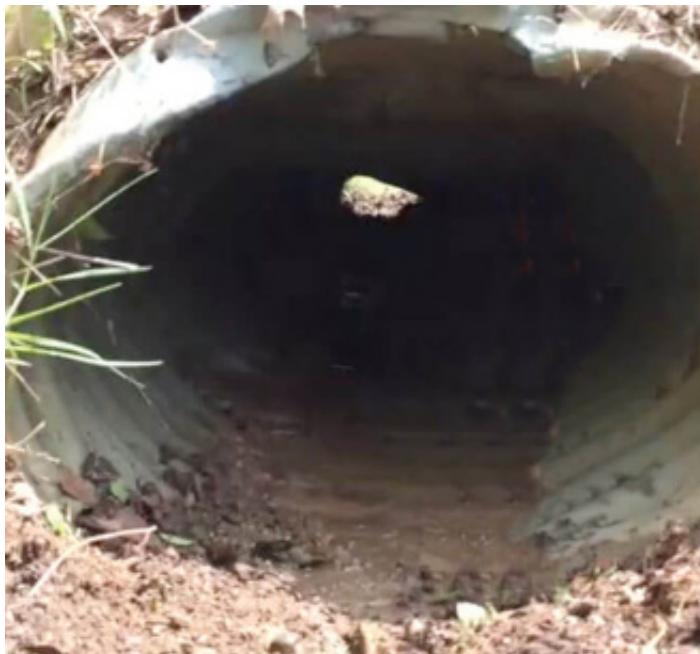
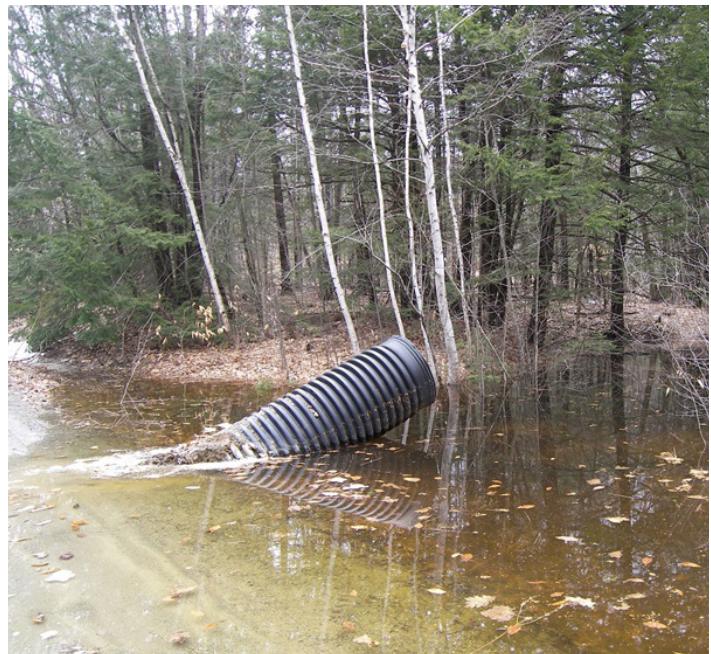
Poor

Light to moderate denting or deformation of inlet and/or outlet end of flexible pipe culvert. The invert of the inlet is at the streambed elevation (no uplift).
